**PERFORMANCE OF
20MM ABLATIVE AMMUNITION**

CORNELL AERONAUTICAL LABORATORY, INC.

TECHNICAL REPORT AFATL-TR-71-164

DECEMBER 1971

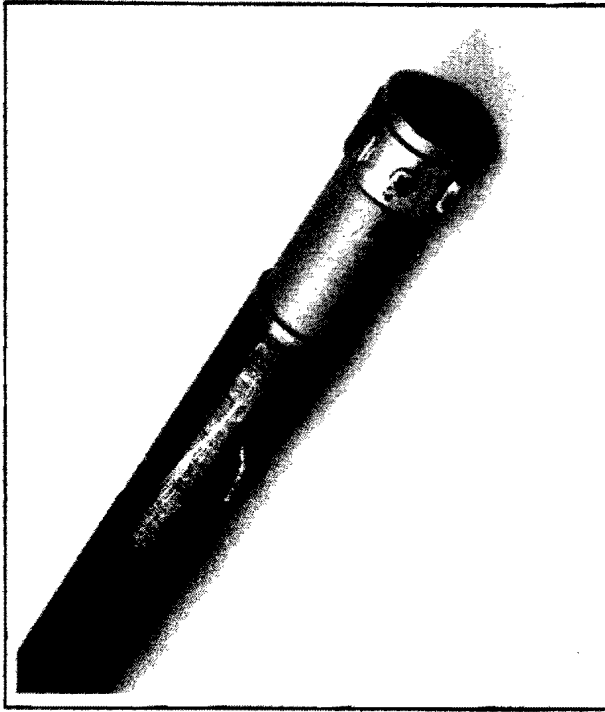
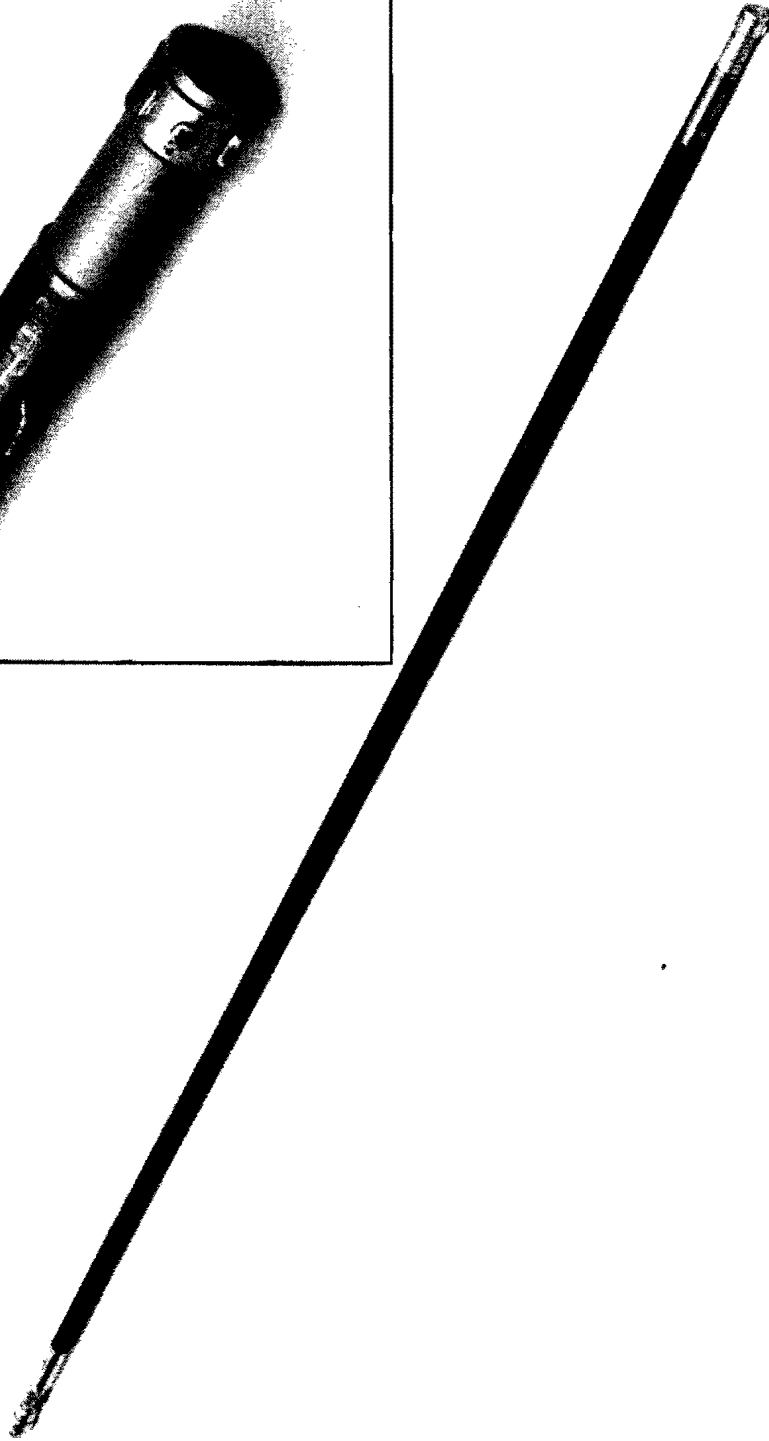
Figure 6. 20mm Bore Gauge
